# Manhole Inspection Summary

Manhole # S25EE\_031MH

Insp Date: **10/11/07 8:34 AM**

**Location** Address: **1143 FREEMONT AVE**

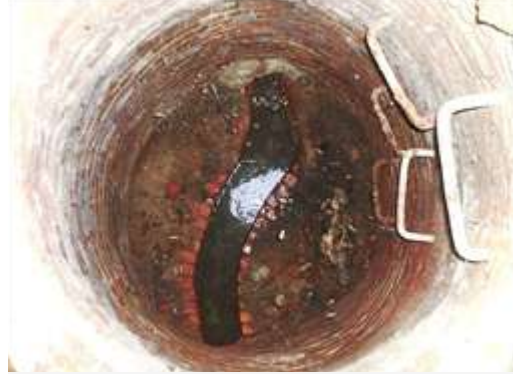
Top View

Count: **5** Missing: **0** ☒ **Corroded**

☒ **Evidence Of Surcharge** Depth: **3** (ft.) ☐ Active Surcharge Present

Corroded steps. Evidence of surcharge - Bench debris. Channel debris.

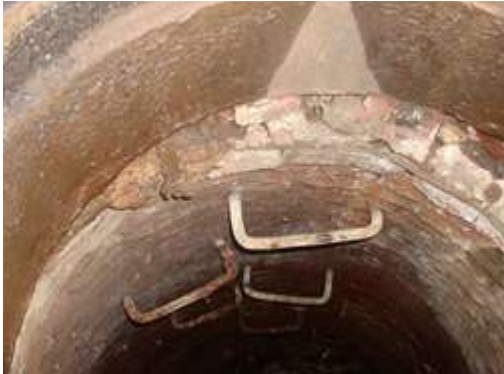
Defect

Condition: ☐ Sound ☐ Cracked ☒ **Leaks**

Condition: ☐ Sound ☐ Cracked ☐ Root Intrusion ☒ **Loose Brick** ☒ **Deteriorated**

Infiltration: ☐ None ☒ **Joint** ☐ Cracks ☐ Mortar ☐ Roots ☒ **Wall**

Frame leaks. Frame offset. Adjustment deterioration, loose brick and infiltration. Barrel infiltration - other side.

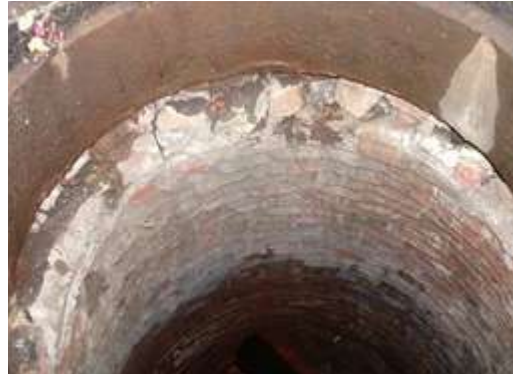
Defect

Frame leaks. Frame offset. Adjustment deterioration and infiltration. Barrel infiltration.

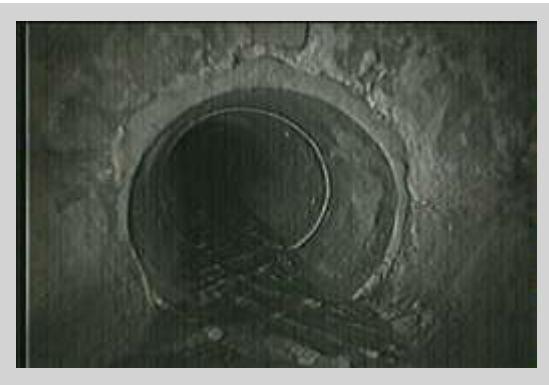
### 8 in. Circular Gravity Sewer Pipe Out @ 12 O'Clock

Infiltration: **None** Pipe Seal Cond: **Cracked**

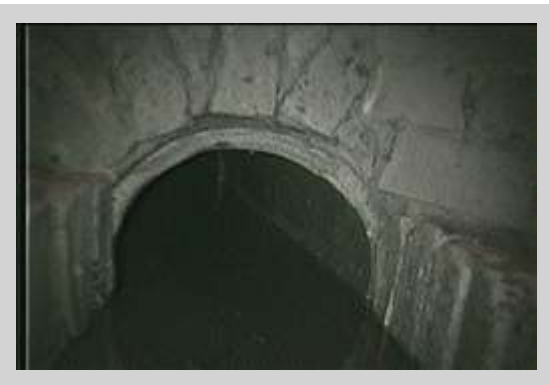
### 8 in. Circular Gravity Sewer Pipe In @ 6 O'Clock

Infiltration: **Evidence** Pipe Seal Cond: **Unknown**
